## PW4000-112" HPT STAGE-2 VANE NEW REPAIR- REPAIR 42 RING SEGMENT MATEFACE RESTORATION REPAIR

P&W Engine Manual Ref: [72-52-34-300-042](#):  
[Ring Segment Mateface Restoration Repair](#)  
Model: [PW4074](#), [PW4077](#), [PW4074D](#), [PW4077D](#),  
[PW4084D](#), [PW4090](#), [PW4090-3](#)  
ATA#: [72-52-34](#)  
SB Ref: N/A

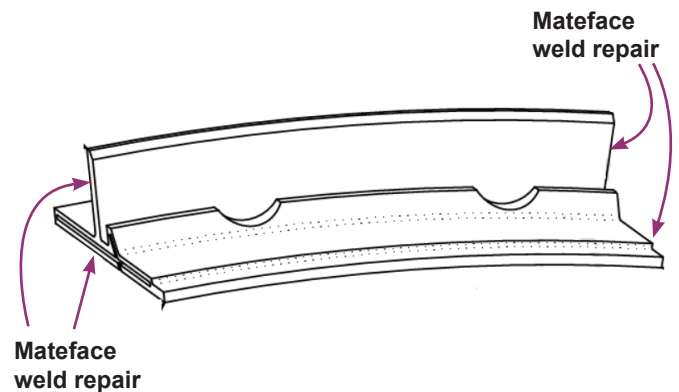
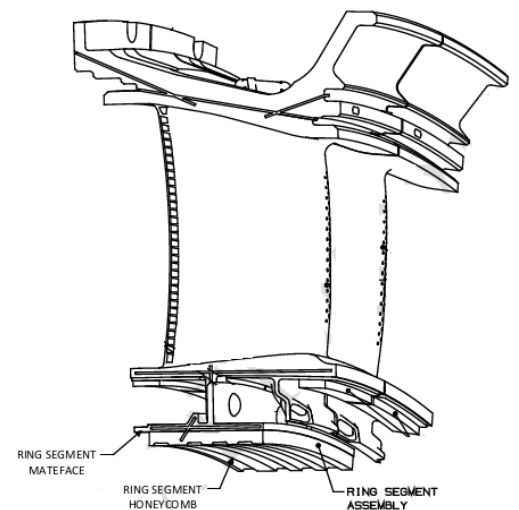
Location of Ring Segment Mateface Weld Repair

The new PW4000-112" HPT Stage-2 Vane Ring Segment Mateface Restoration repair reduces total cost of ownership and extends part life by restoring the ring segment mateface via welding and EDM. Previous to this repair, 25% of the ring segment would need replacement resulting in multiple repair cycles during assembly.
