## PW4000-94"/100" LPT STAGE-3 VANE ALTERNATE BOLT HOLE REPAIR

P&W Engine Manual Ref: [REPAIR 25](#),

Model: [PW4000-94"/100"](#)

ATA#: [72-53-23](#)

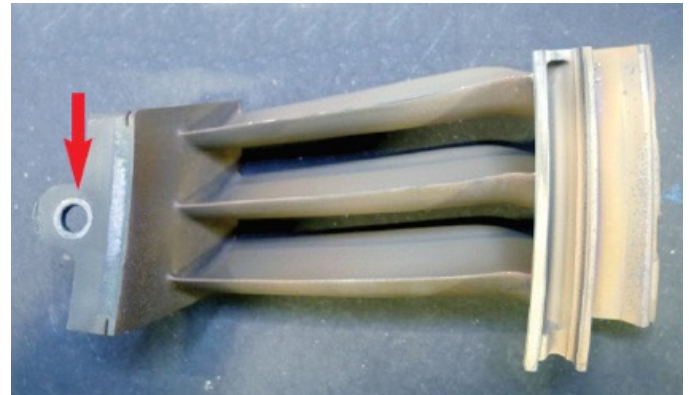
Pre-repair

The new repair for the PW4000-94"/100" LPT Stage-3 Vane developed by Pratt & Whitney increases overall yield, reduces total cost of ownership and minimizes part scrap. This alternate bolt hole repair (Refer to Figure 01) aims to salvage parts previously deemed not salvageable, achieving an estimated 3% reduction in scrapped parts.

Figure 1: Example of Bolt Hole Repair
